POTENTIAL and EXISTING UPSTREAM RESERVOIR SITES SUDBURY, ASSABET & CONCORD STUDY AREAS

POTENTIAL AND EXISTING UPSTREAM RESERVOIR SITES

U.S. DEPARTMENT OF AGRICULTURE Soil Conservation Service Amherst, Massachusetts

In cooperation with the Massachusetts Water Resources Commission

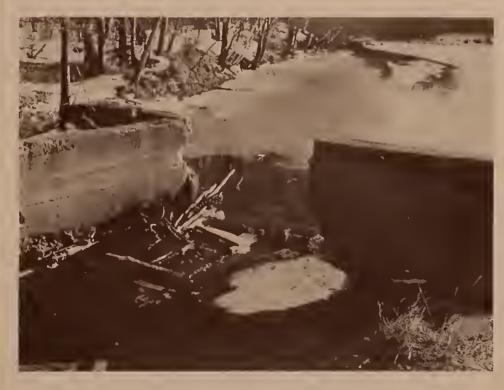
AS-1747 (Eaton Pond) Breached Spillway
